#### 2018 EAST SIDE OF HURRICANE MICHAEL AT THE FSUCML

# POST HURRICANE MICHAEL

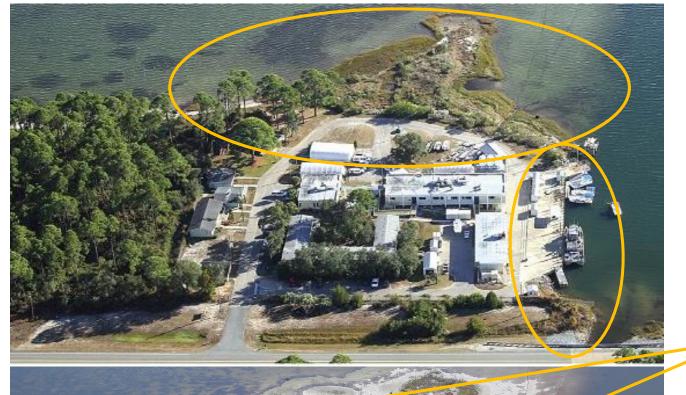
Storm Surge Effects

- Loss of structure
  - Guest house
  - Mesocosm deck
  - Viewing platform
  - > Several gear sheds & contents
  - > Greenhouses
